# Navajo Abandoned Uranium Mine

# Site Screen Report

Mine Name: **Gwen claim**Mine ID: **851**

**April 2012**

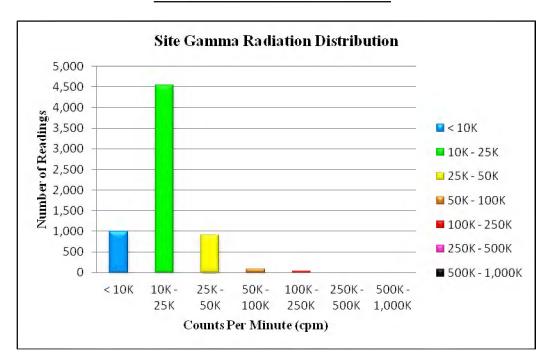
**Highest gamma radiation measurement:** 140,130 counts per minute (cpm)

**Background Average:** 12,416 cpm **Two Times Background:** 24,832 cpm

A total of 6,582 gamma radiation measurements were collected from the mine site, ranging from 5,880 cpm to 140,130 cpm. The measurements are represented in Figures 1 and 2.
